**DRAFT ANALYSIS OF BROWNFIELDS CLEANUP
ALTERNATIVES/ REMEDIAL ACTION PLAN**

Ernie's Auto Sales Property
180 East Main Street
Tilton, New Hampshire
NHDES # 199311019

**Ernie's Auto Sales Property
180 East Main Street
Tilton, New Hampshire
NHDES Site #199311019**

In Reference to:
Project No. 12001162

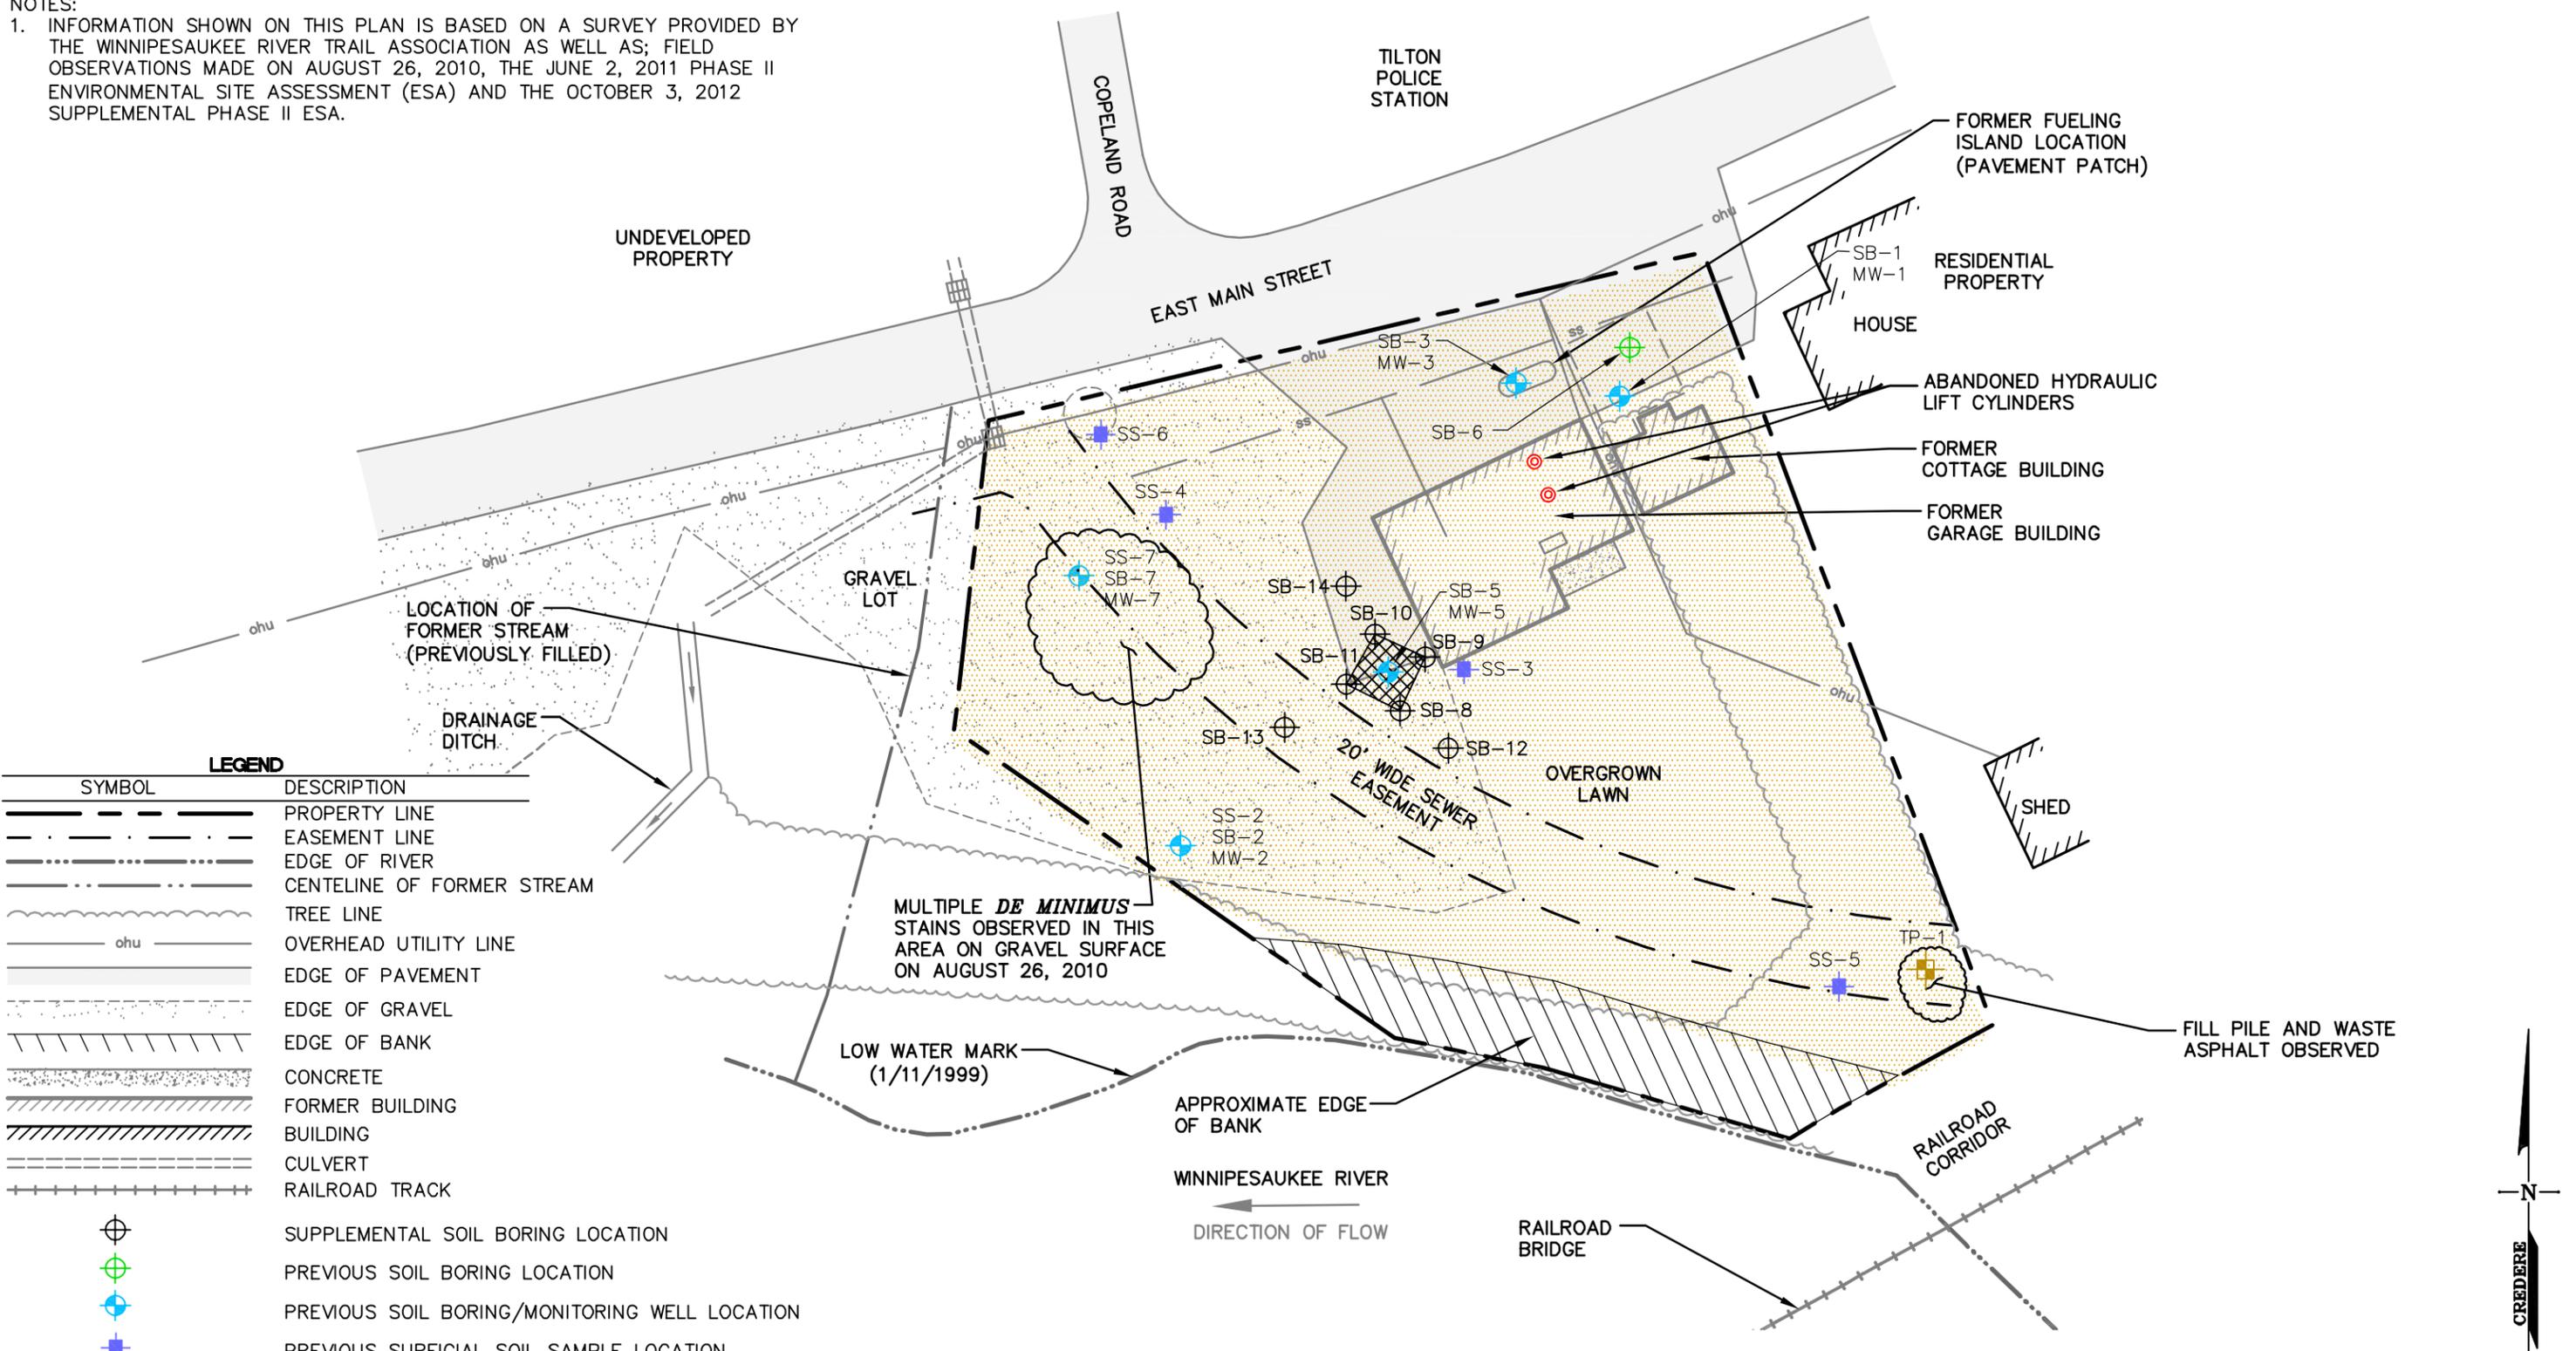
1. INFORMATION SHOWN ON THIS PLAN IS BASED ON A SURVEY PROVIDED BY THE WINNIPESAUKEE RIVER TRAIL ASSOCIATION AS WELL AS; FIELD OBSERVATIONS MADE ON AUGUST 26, 2010, THE JUNE 2, 2011 PHASE II ENVIRONMENTAL SITE ASSESSMENT (ESA) AND THE OCTOBER 3, 2012 SUPPLEMENTAL PHASE II ESA.

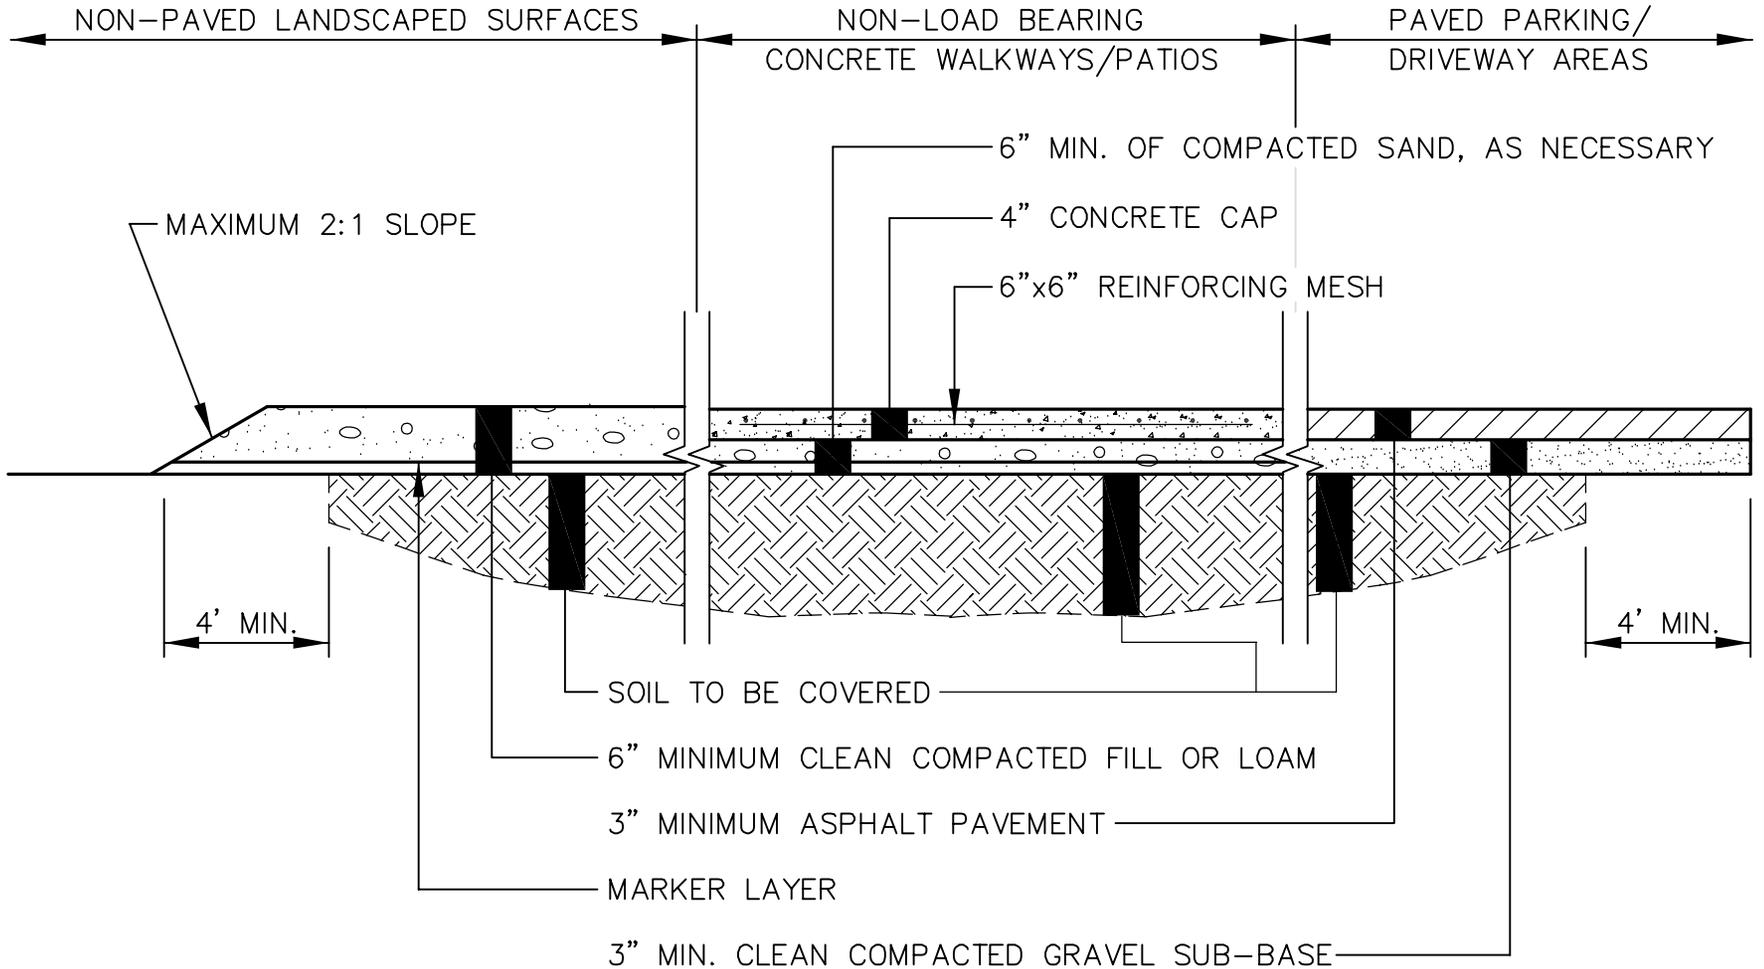
SKETCH NO:
FIGURE 4

THE QUANTITIES IDENTIFIED ARE MINIMUM REQUIREMENTS FOR COVERING OF THE IDENTIFIED CONTAMINATED SOILS. ADDITIONAL SUB-BASE MATERIALS MAY BE REQUIRED IN AREAS PROPOSED FOR ASPHALT PAVING AND/OR CONCRETE SIDEWALKS/PATIOS, AS NECESSARY, TO MAINTAIN STRUCTURAL INTEGRITY OF THESE MATERIALS.

A typical detail for a clean fill, asphalt, or concrete cover system to be placed over the identified contaminated soil is presented on **Figure 4**.

A typical covering detail for clean fill/soil, asphalt, and concrete to be placed over the identified contaminated soil is presented on **Figure 4**. The following covering procedures will be implemented during the remedial action:
